ASBESTOS SURVEY REPORT

NATIONAL GUARD ARMORY
200 NE 23RD STREET
BUILDING 1
OKLAHOMA CITY, OKLAHOMA

Enercon Project Number – ENMISC2254

August 8, 2011
(Revised November 15, 2012)

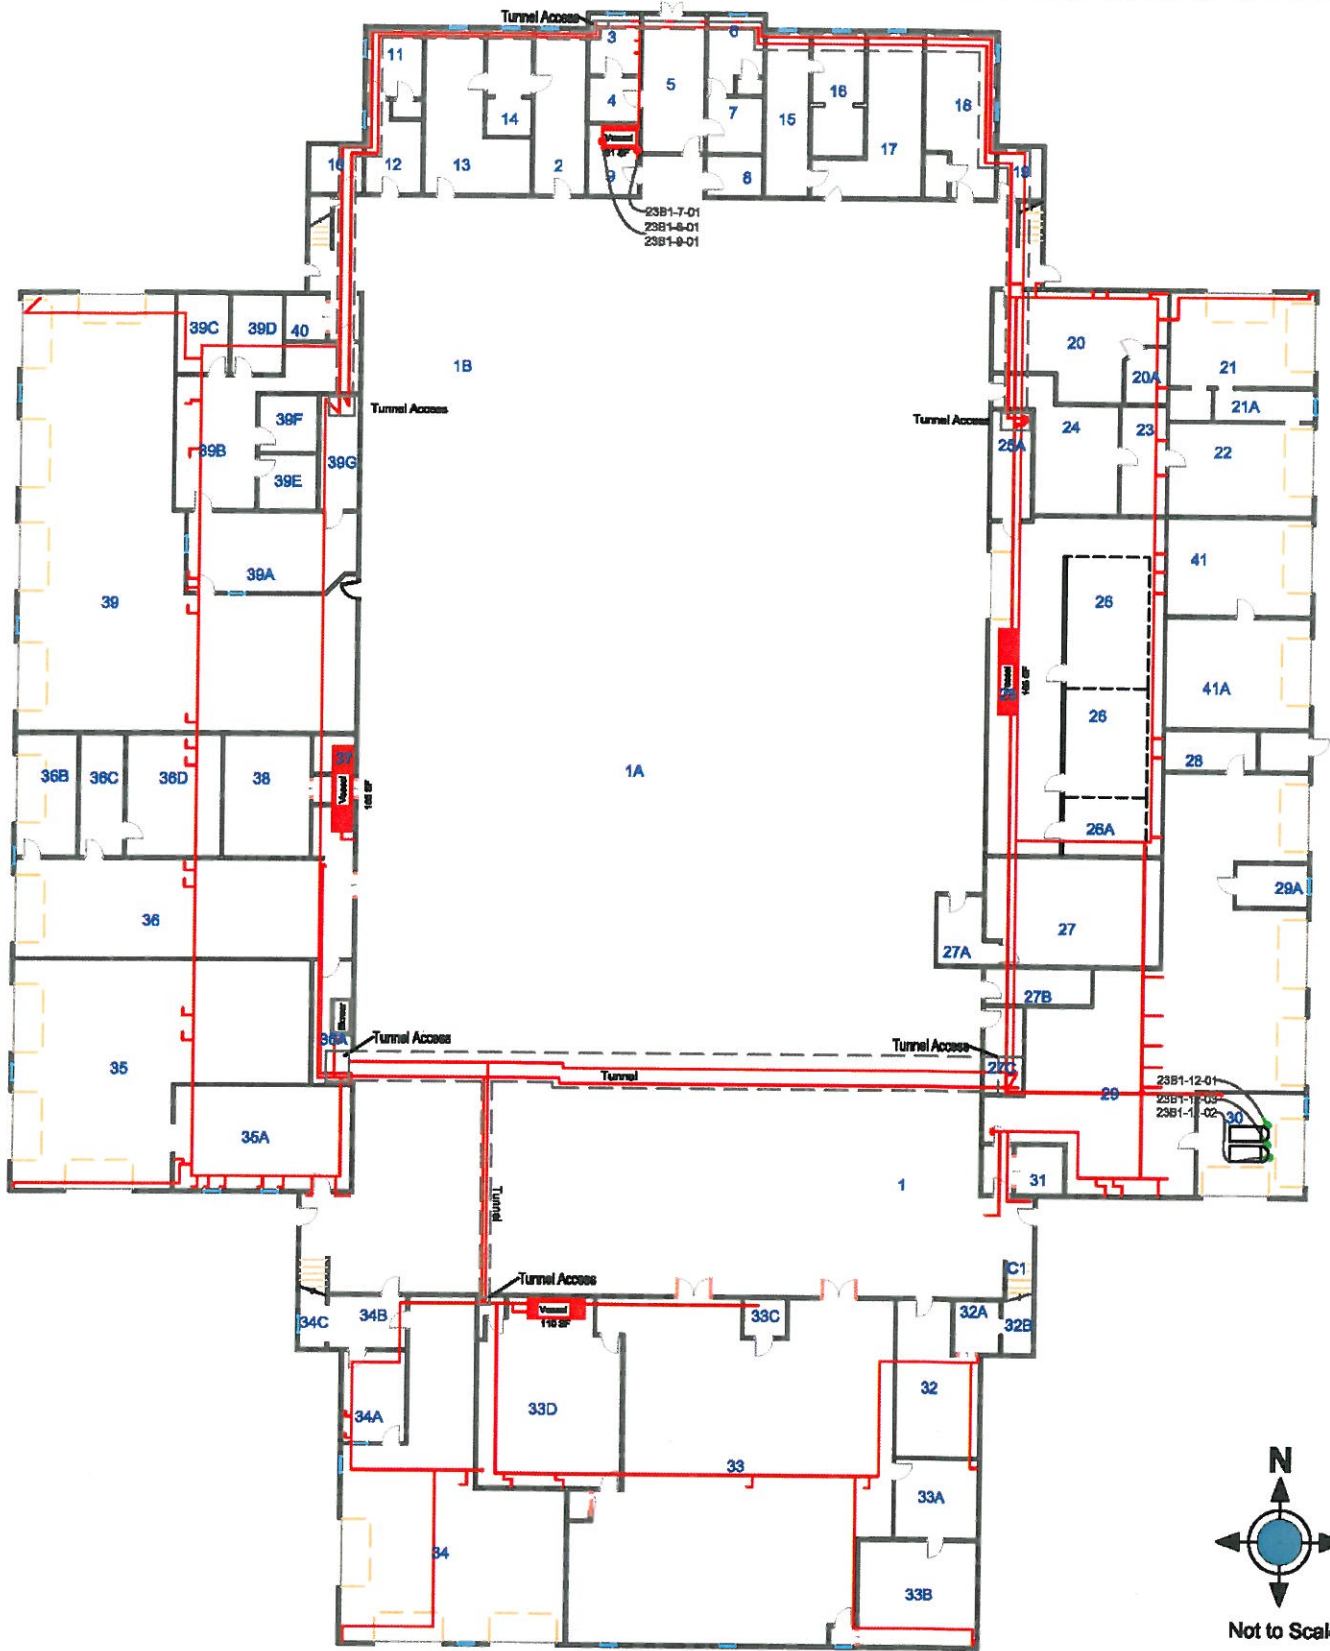
FIGURE 1
Asbestos - Thermal Systems Insulation
Building 1 Floor 1

- Heating Water Fitting and Line Insulation: Approximately 5,490 linear feet in good to poor condition was present on the first and second floors and in pipe tunnels. Of this, approximately 2,400 linear feet was located on the first floor and 90 linear feet located on the second floor. No insulated piping was found to be present on the third floor. The locations are shown on Figures 1 and 2 in Appendix B.
- Heating Water Storage Tank Insulation: Approximately 521 SF of insulation in good condition was present on four heating water storage/surge tanks located on the first floor. The locations are shown on Figure 1 in Appendix B.

- = Asbestos Piping and Fittings @ 2400 LF
- = 4-Tank / Vessels totaling 521 SF

1. Planned renovation and maintenance activities that could disturb friable asbestos: Determine scope of piping and heating water storage tanks to be abated versus that to manage in place; prepare project design/abatement specifications for friable asbestos that would be disturbed during renovation activities; solicit bids; award contract and complete abatement.
2. Planned demolition: Prepare specifications for abatement of all friable asbestos materials; solicit bids; award contract and complete abatement.
3. Continued operation without abatement of all friable asbestos: Prepare and implement an Asbestos Management Plan to manage the remaining asbestos in place. This is to include Asbestos Awareness Training for maintenance and custodial personnel.

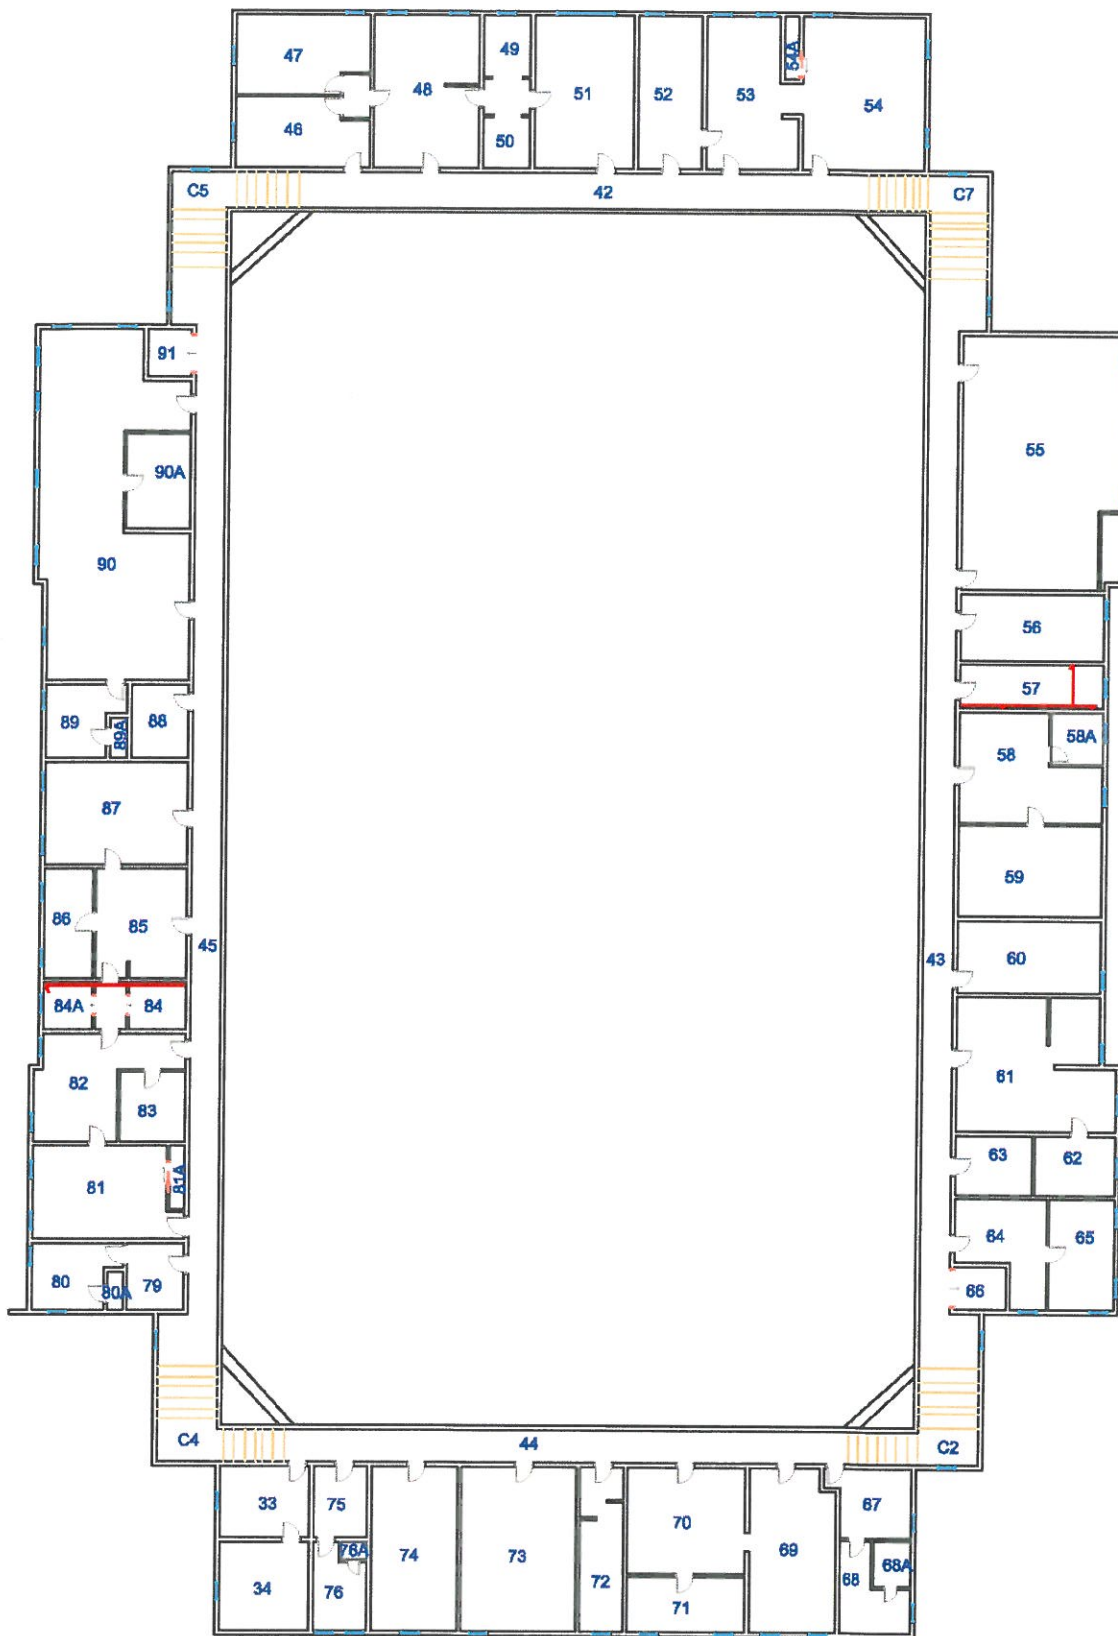
FIGURE 2
Asbestos Thermal Systems Insulation
Building 1 Floor 2

— Asbestos Piping and Fittings 90 LF @ 4-6"

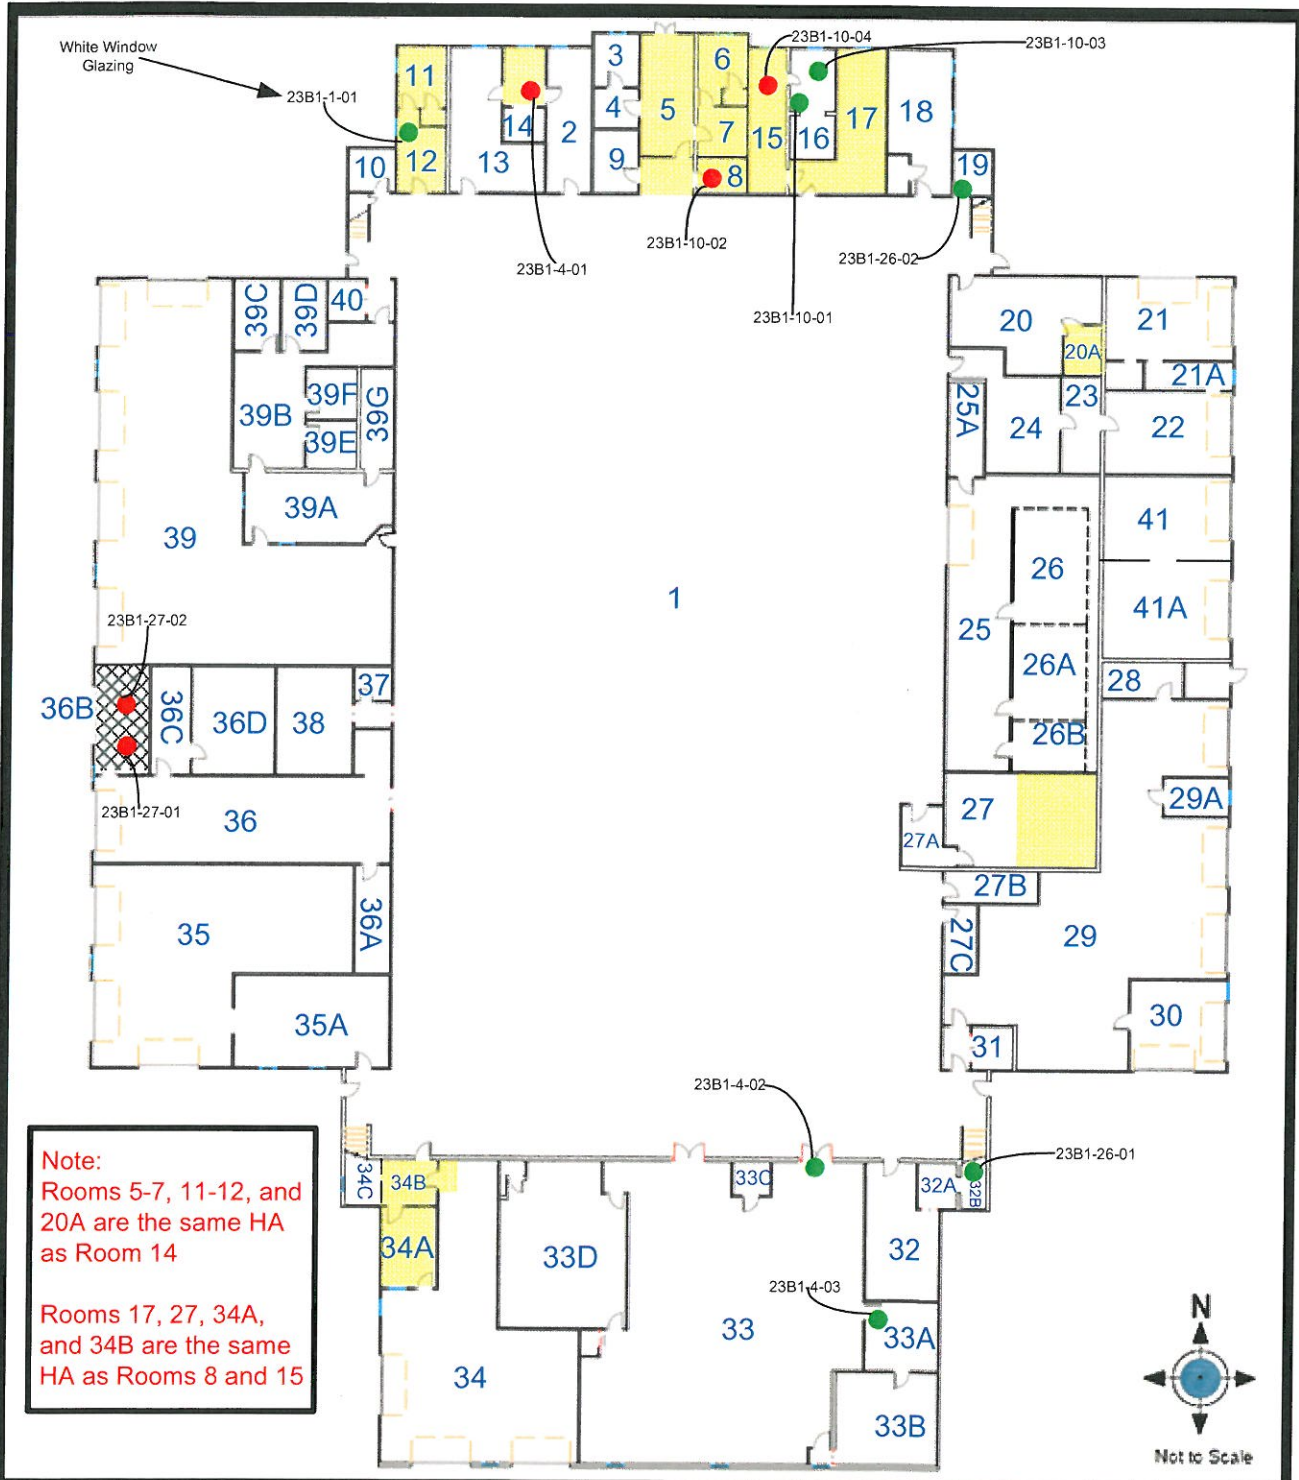
FIGURE 3
Asbestos - Miscellaneous Materials & Sample Locations - Building 1 Floor 1

- Legend:**
- Positive Sample Location
 - Negative Sample Location
 - 1'x1' Floor Tile ACM - NA
 - 9"x9" Floor Tile ACM - 350 SF
 - Mastic Only ACM - 2,450 SF

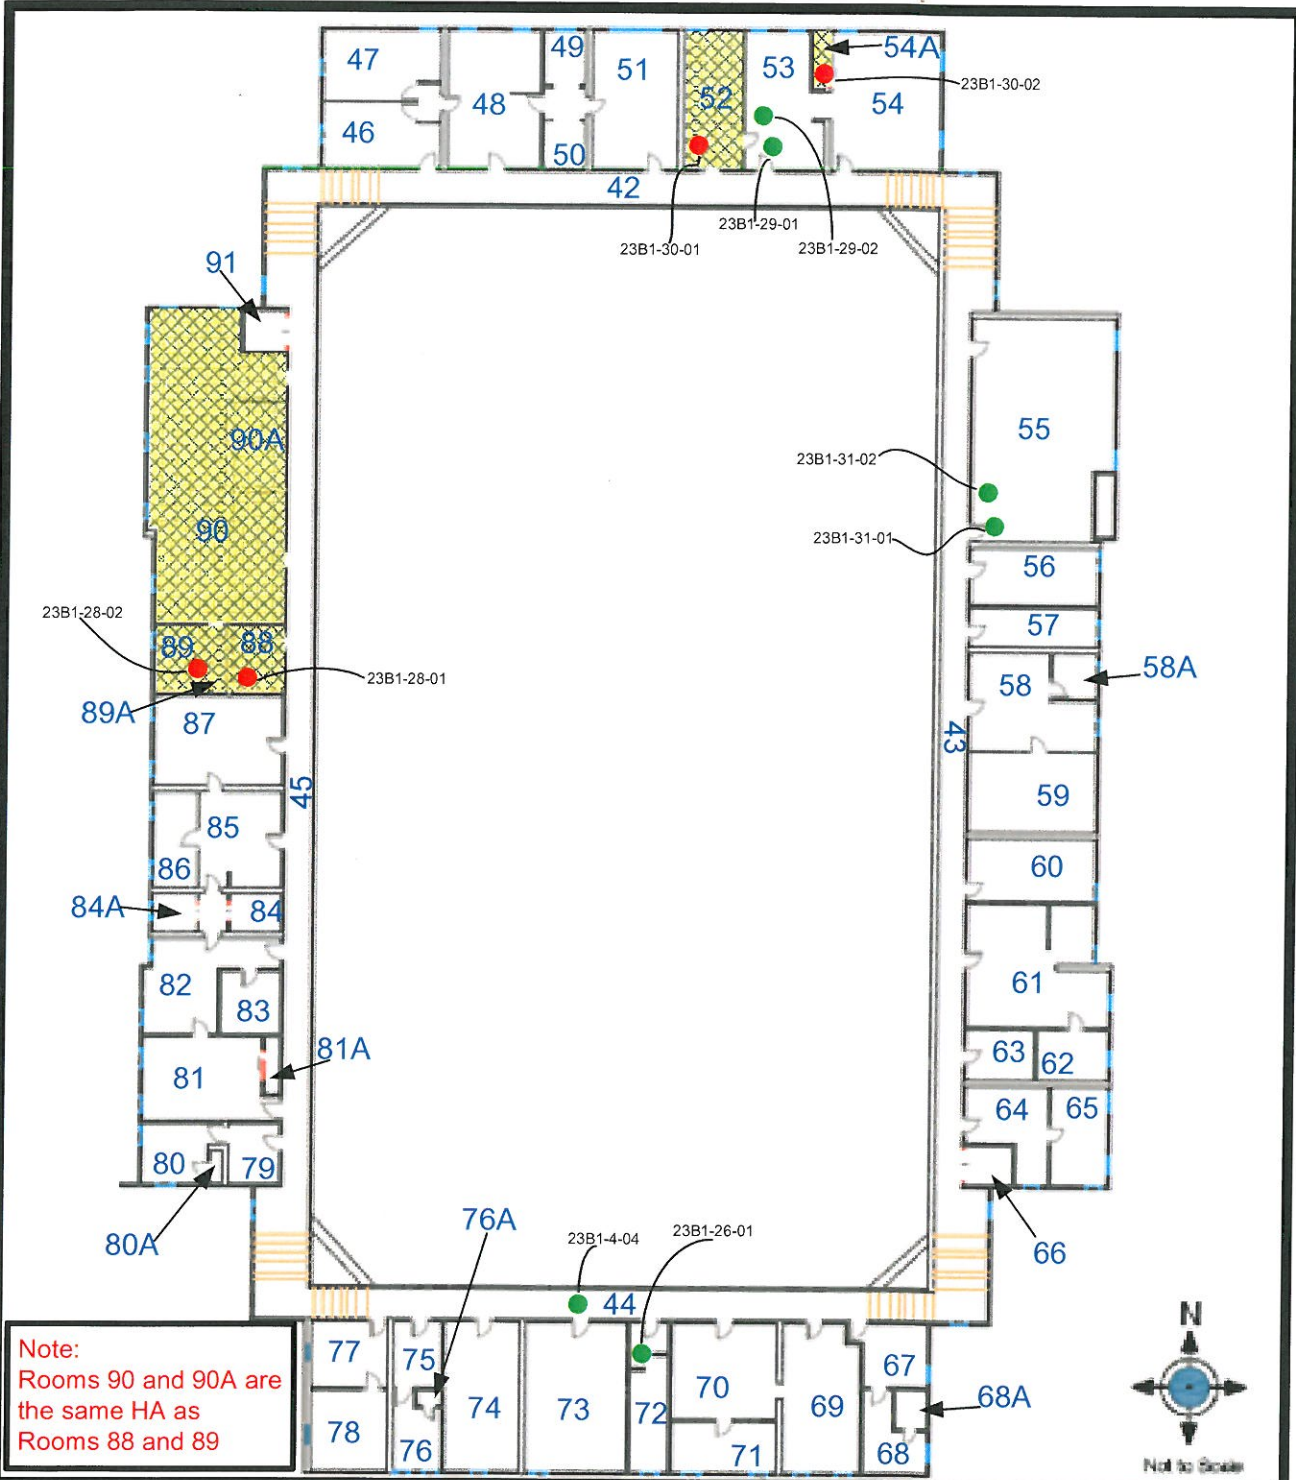
FIGURE 4
Asbestos - Miscellaneous
Materials & Sample Locations
- Building 1 Floor 2

Note:
 Rooms 90 and 90A are
 the same HA as
 Rooms 88 and 89

- Legend:**
- Positive Sample Location
 - Negative Sample Location
 - ▨ 1'x1' Floor Tile ACM - NA
 - ▩ 9'x9" Floor Tile ACM - 1,980 SF
 - Mastic ACM - 1,980 SF

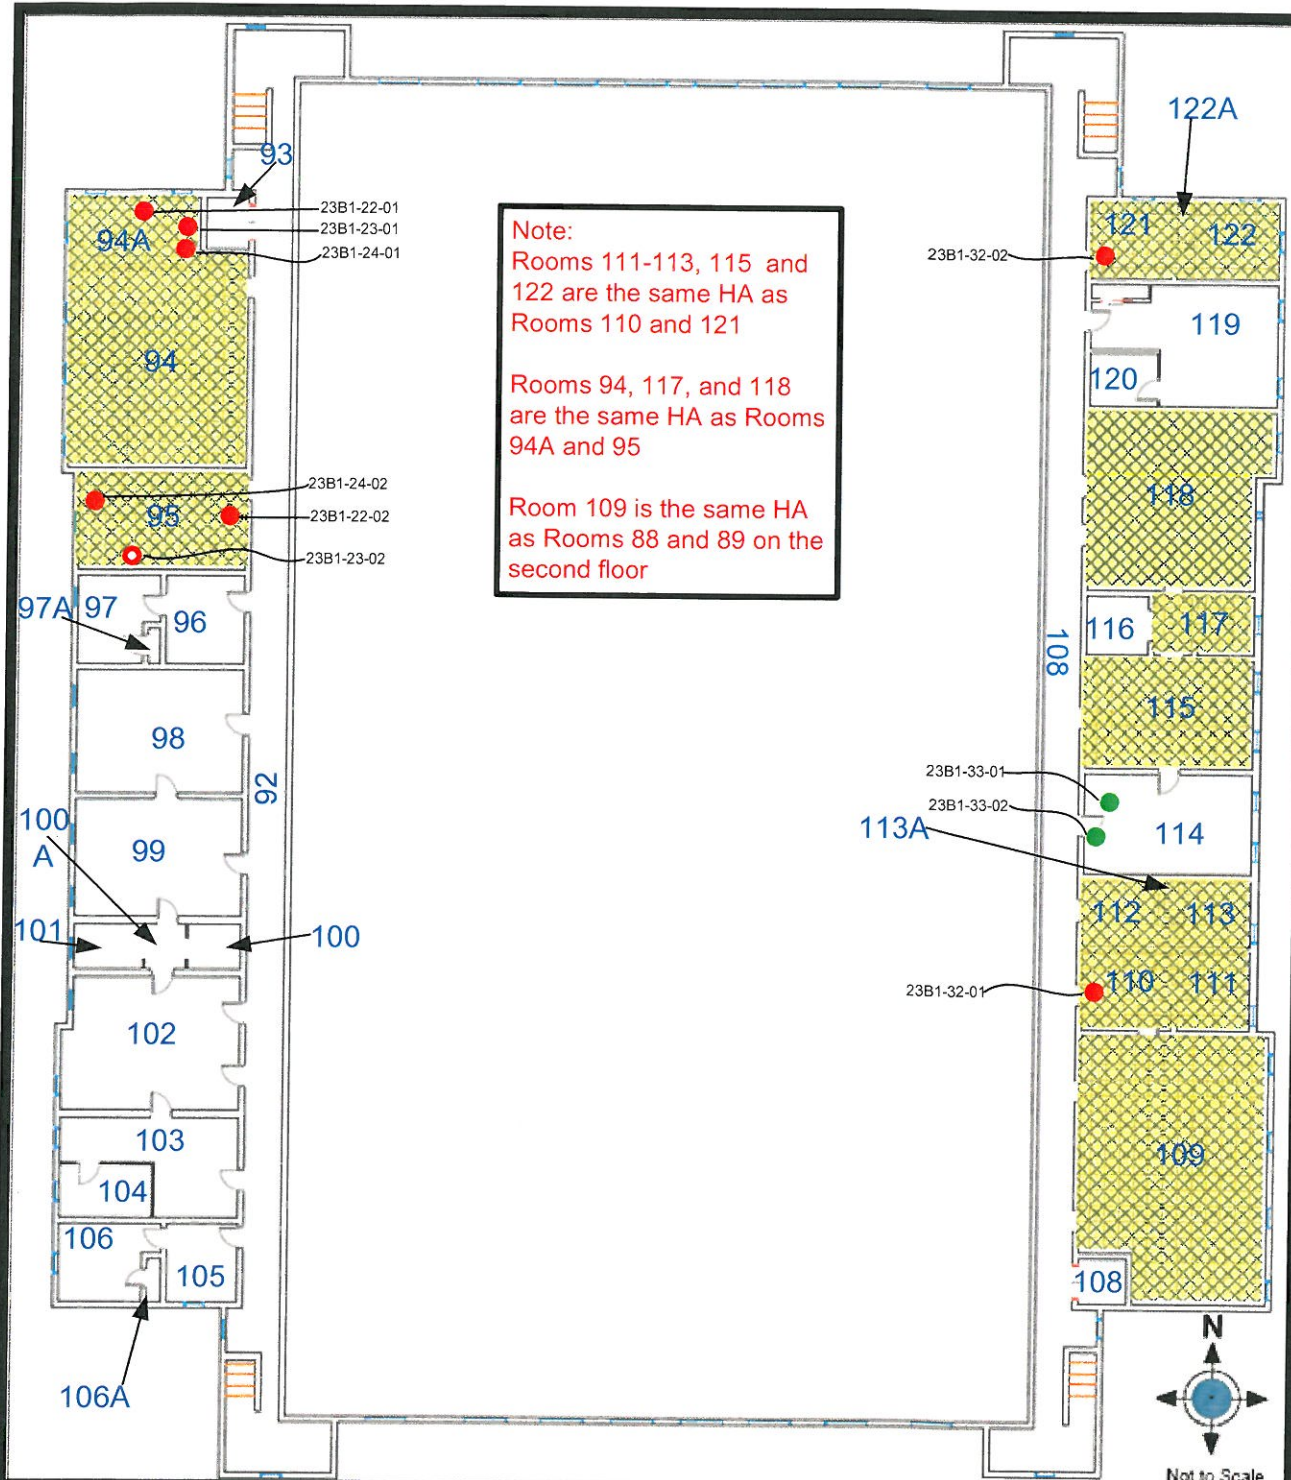
FIGURE 5
Asbestos - Miscellaneous Materials Sample Locations - Building 1 Floor 3

Note:
 Rooms 111-113, 115 and 122 are the same HA as Rooms 110 and 121
 Rooms 94, 117, and 118 are the same HA as Rooms 94A and 95
 Room 109 is the same HA as Rooms 88 and 89 on the second floor

- Legend:**
- Positive Sample Location
 - Negative Sample Location
 - ▨ 1'x1' Floor Tile ACM - NA
 - ▨ 9"x9" Floor Tile ACM - 4,600 SF
 - Mastic ACM - 4,600 SF

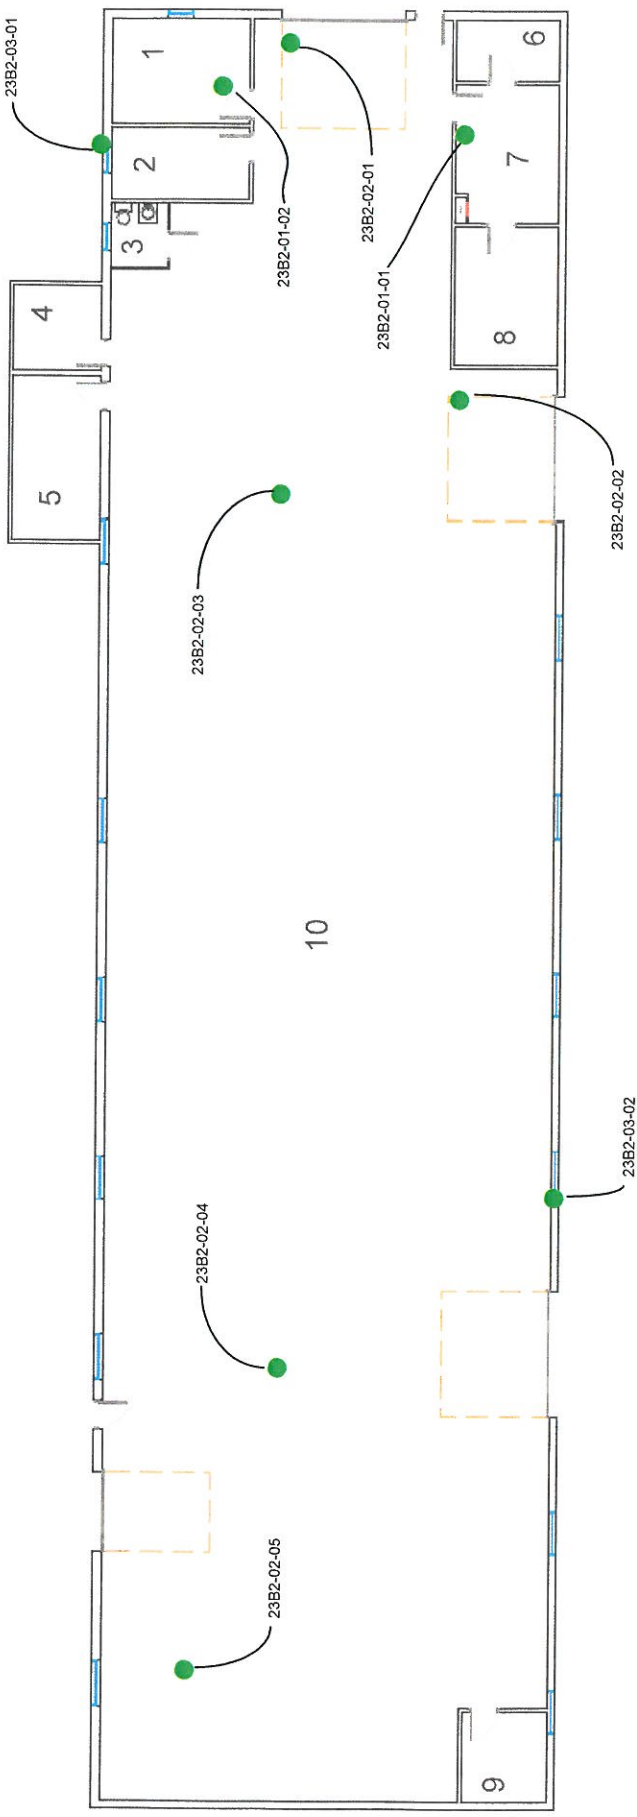
No regulated levels of friable ACBM or non-friable ACBM were found to be present in Building 2.

NOTE: No asbestos present in Building 2.

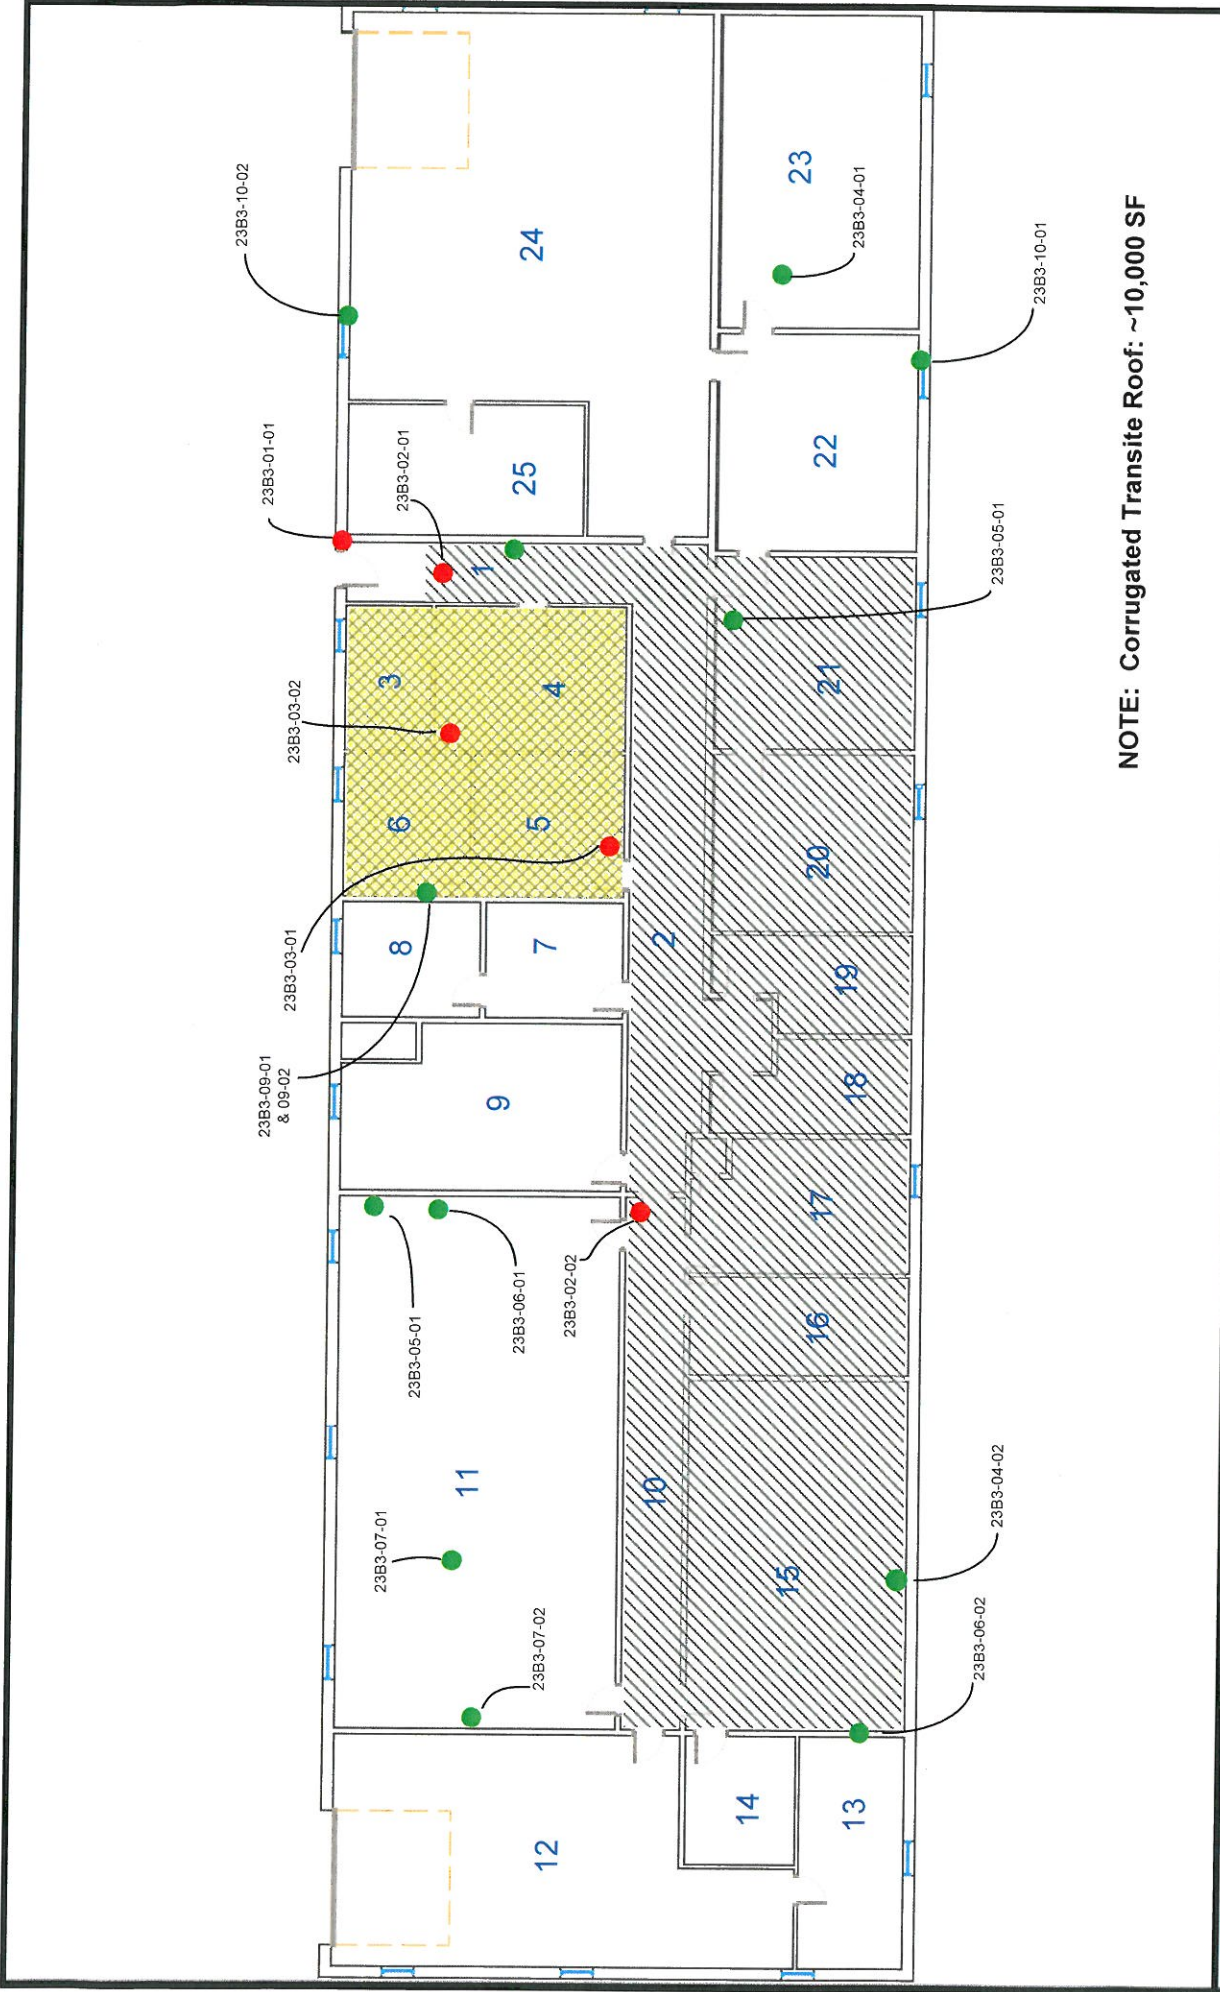
Samples of corrugated Transite roof panels, floor tiles/mastic, drywall, drywall joint compound, wall texture, ceiling tiles and window glazing were collected and analyzed for asbestos content. A total of 19 samples from ten homogeneous areas were collected. Floor tiles/mastic contained 6-12% Chrysotile and the corrugated Transite roof panels contained 20% Chrysotile. No other suspect materials were found to be present in the building. The floor tiles/mastic are Category I Non-friable asbestos and the Transite roof panels are Category II Non-friable asbestos. There was approximately 625 SF of ACM floor tiles/mastic, 2,700 SF of ACM floor tiles with non-asbestos mastic and approximately 10,000 SF of Transite roof panels present.

NOTE: Corrugated Transite Roof: ~10,000 SF

If the building is to be continued in use, preparation of an Asbestos Management Plan is recommended for management of these materials in place. If the building is to be demolished, the Transite roof panels must be removed by properly trained personnel prior to demolition. The floor tiles and mastic may remain in place during demolition.

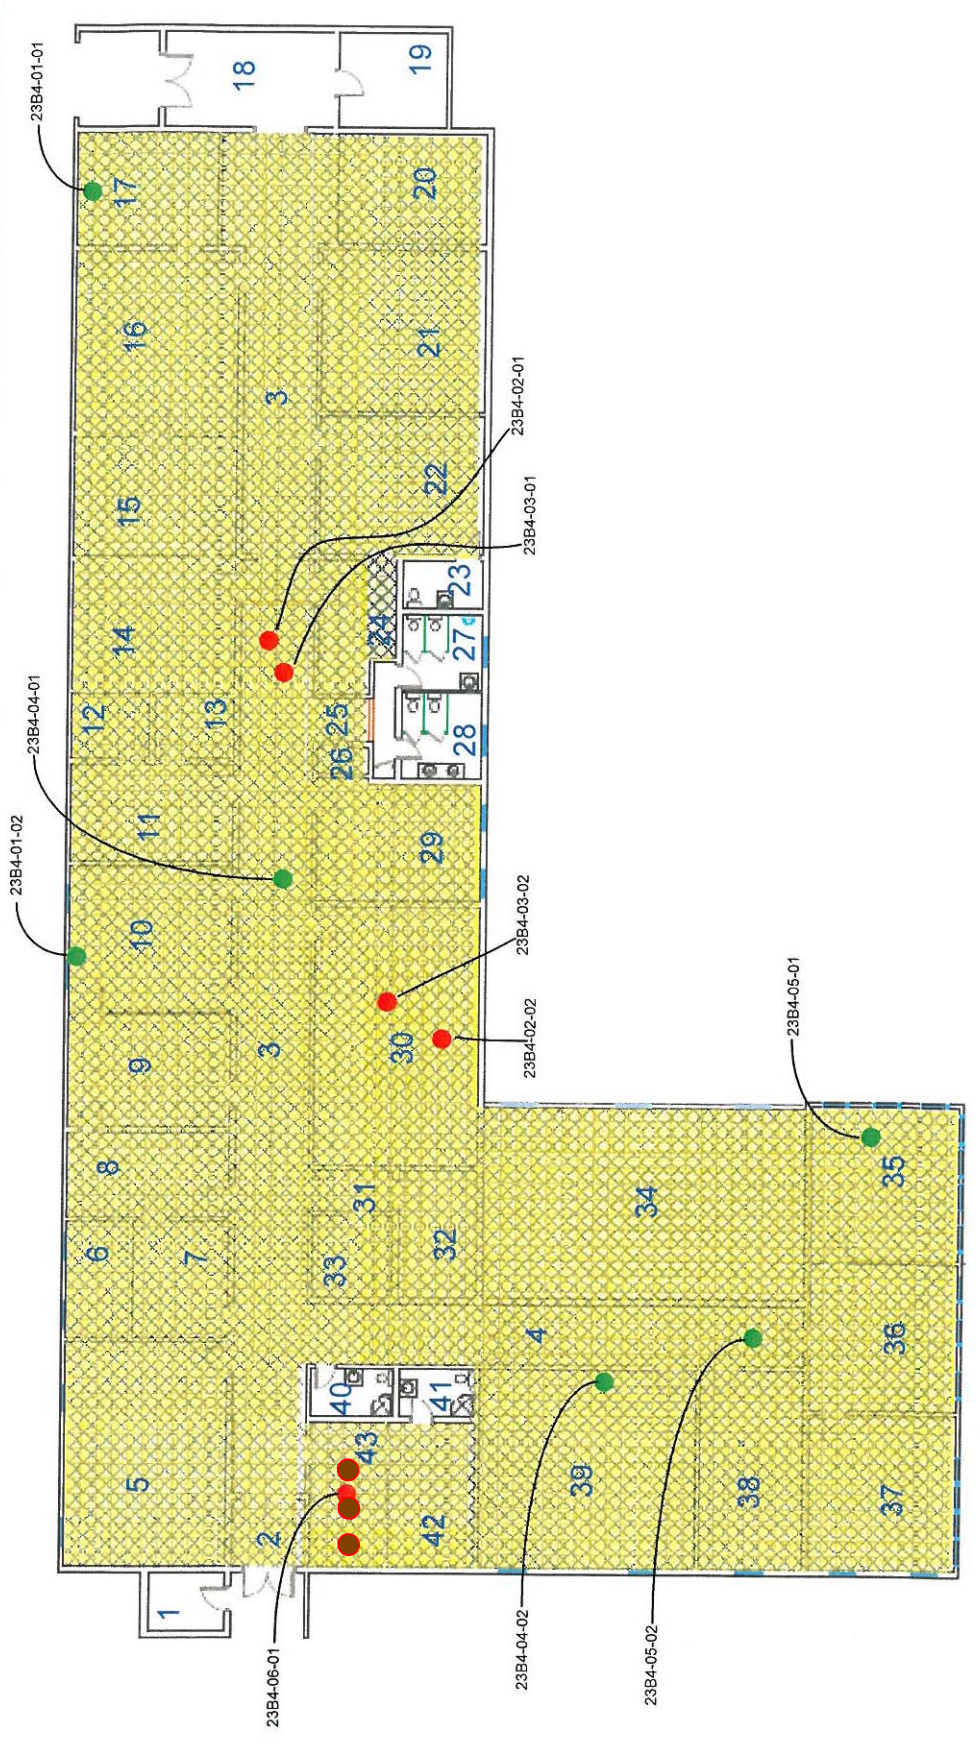
Samples of window glazing, floor tiles/mastic, drywall joint compound, ceiling tiles and Transite flue piping were collected and analyzed for asbestos content. A total of eleven samples from six homogeneous areas were collected. Floor tiles/mastic contained 2-4% Chrysotile and three Transite flues contained 10% Chrysotile and 15% Crocidolite. No other suspect materials were found to be present in the building. The floor tiles/mastic are Category I Non-friable asbestos and may remain in place during demolition. There was approximately 12,100 SF of floor tiles/mastic and approximately 45 LF of Transite flues. The Transite flues must be removed by properly trained personnel prior to demolition of the building.

- Legend:**
- Positive Sample Location
 - Negative Sample Location
 - 1'x1' Floor Tile ACM - NA
 - 9'x9" Floor Tile ACM - 12,100 SF
 - Mastic ACM - 12,100 SF
 - Transite Flues - 45 LF

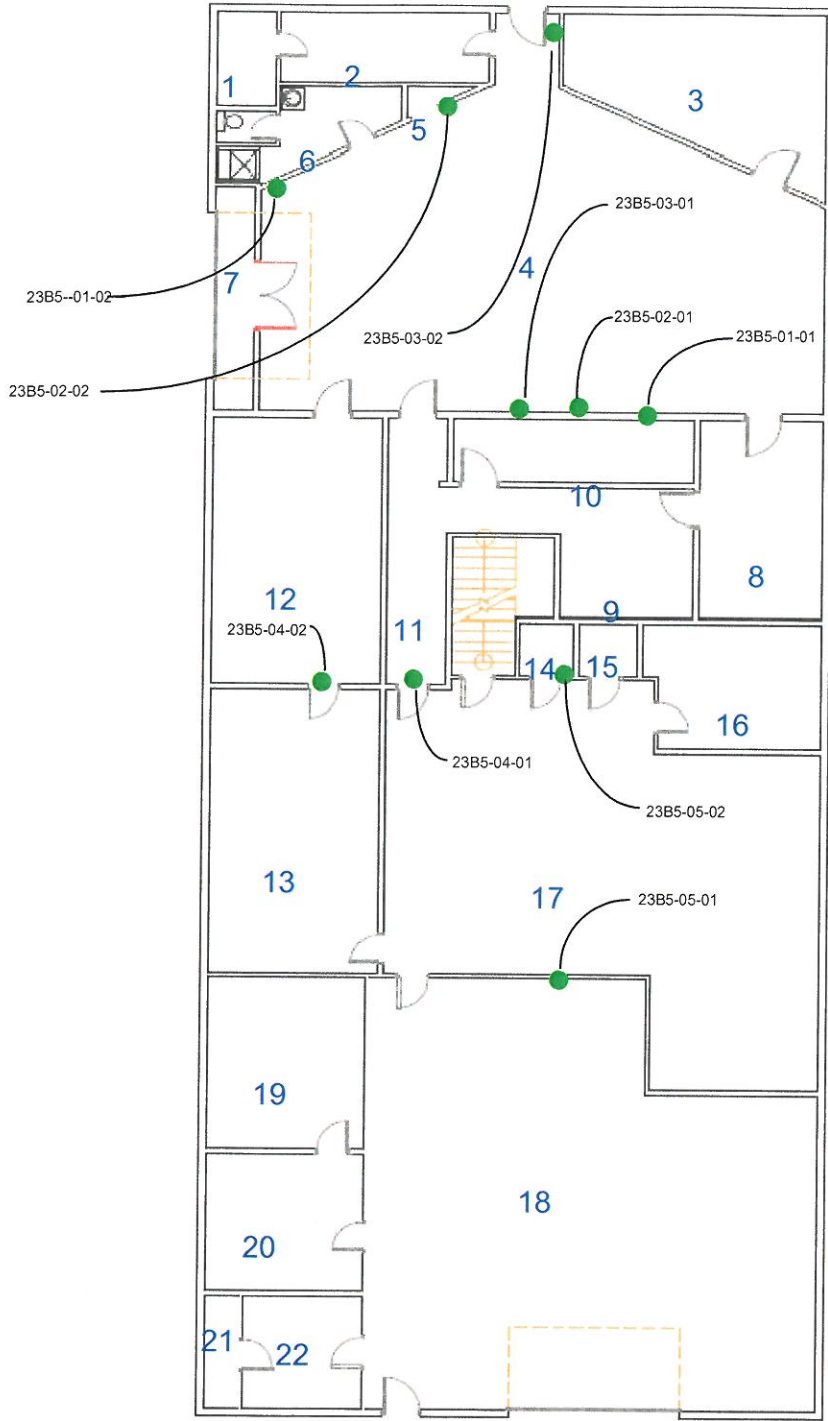
No regulated levels of friable ACBM or non-friable ACBM were found to be present in Building 5.

NOTE: No asbestos present in this building.
